Manhole Inspection Summary

Manhole # S51A__004MH

Insp Date: **5/6/08 8:48 AM**

Location Address: **rear 511 kenwood**

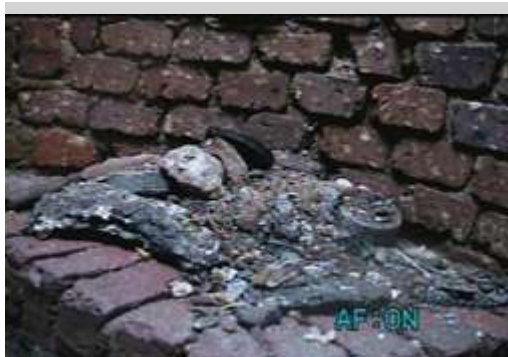
Misc

bench debris

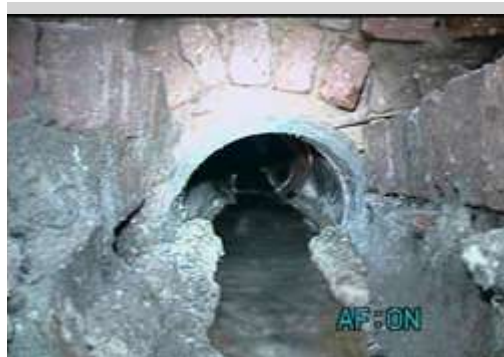
Defect 3

Condition: ☐ Sound ☐ Cracked ☐ Root Intrusion ☒ **Deteriorated** ☐ Leaks ☐ Debris

Deteriorating Channel

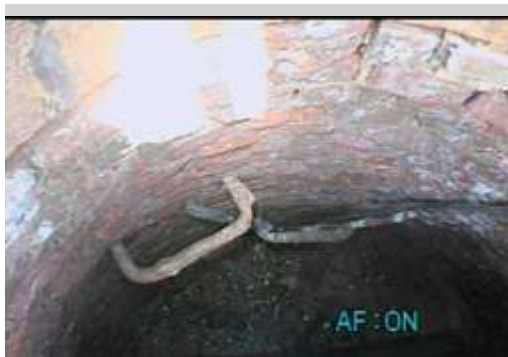
Defect 2

Steps Count: **3** Missing: **1** ☒ **Corroded**

steps

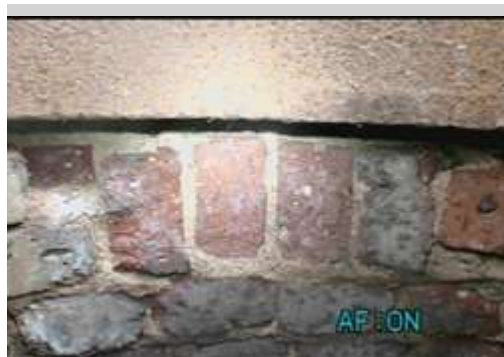
Defect 1

Condition: ☐ Sound ☐ Cracked ☐ Root Intrusion ☐ Loose Brick ☒ **Deteriorated**

deteriorated, frame adjustment

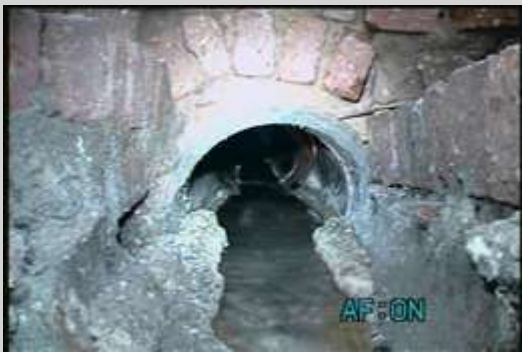
12 O'Clock Outflow

8 in. Circular Gravity Sewer
Pipe Out @ 12 O'Clock

Invert Depth: 7.66 (ft.) Flow Characteristics: **Fast**

Infiltration: **None** Pipe Seal Cond: **Unknown**

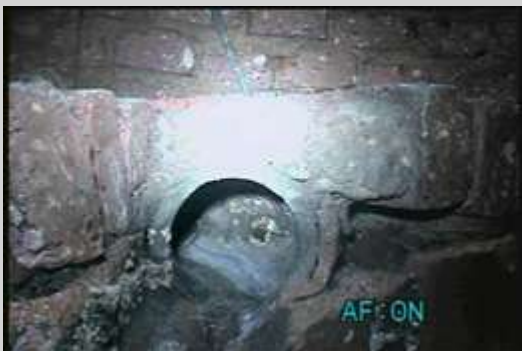
3 O'Clock Inflow

6 in. Circular Gravity Sewer
Pipe In @ 3 O'Clock

Invert Depth: 7.30 (ft.) Flow Characteristics: **Slow**

Infiltration: **None** Pipe Seal Cond: **Unknown**

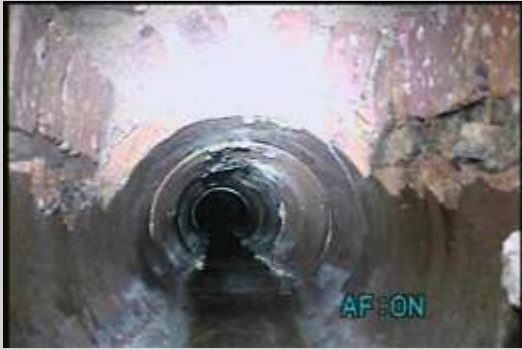
6 O'Clock Inflow

8 in. Circular Gravity Sewer

Pipe In @ 6 O'Clock

Invert Depth: **7.61** (ft.) Flow Characteristics: **Fast**

Infiltration: **None** Pipe Seal Cond: **Unknown**

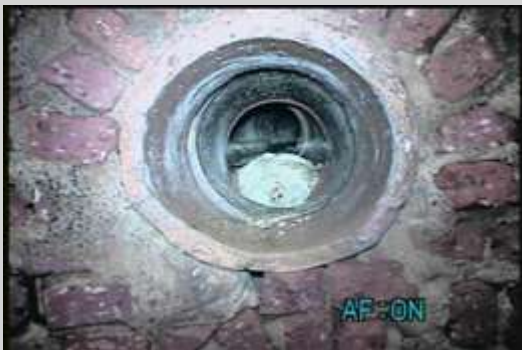
9 O'Clock Inflow

8 in. Circular Gravity Sewer

Pipe In @ 9 O'Clock

Invert Depth: **6.11** (ft.) Flow Characteristics: **Fast**

Infiltration: **None** Pipe Seal Cond: **Unknown**

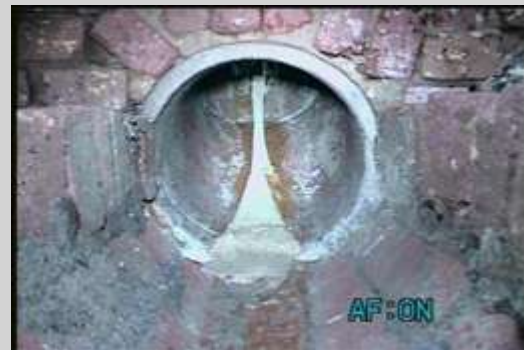
Drop In @ 9 O'Clock

Drop: **Outside Direct**

Inv Depth: **7.31** (ft.)

Drop Condition: **Open**
